# **Cortina Systems<sup>®</sup> LXT971A, LXT972A, LXT972M Single-Port 10/100 Mbps PHY Transceivers**

**Specification Update**

**Document Number 249354**

**Revision 13.0**

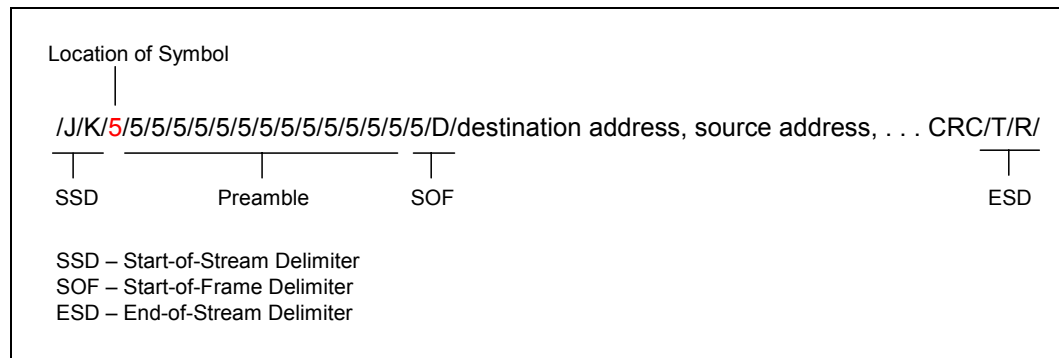
Standard Frame Contents:

**Problem** An illegal symbol placed immediately after the SSD (preamble after JK) is not detected. However, any subsequent corrupt symbol will be detected.

**Implication** RXER does not assert if this symbol location is corrupted. However, an error in this location does not affect packet integrity.

**Workaround** Use the MAC layer protocol to detect corrupt symbols in the packet.
