ST75C520 REVISION 1.4

I - INTRODUCTION

The purpose of this document is helping the customer to use the Revision 1.4 of the ST75C520. So the ST75C520 Revision 1.4 Application Guide answers some questions as :

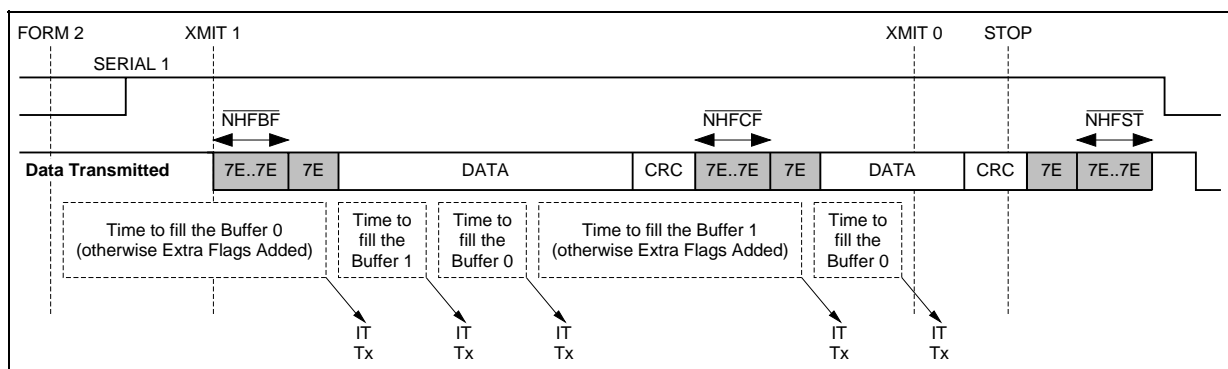
AN919-01.EPS

Figure 1 : Detailed Timing Diagram

The default value for these three variables is 0. The programming range is from 0 to 7FFF (32767) (see Figure 1).
